REINTERPRETING FORT RALEIGH OUTWORK-SCIENCE CENTER Part 1 Structural Reinterpretation

A REPORT BY ERIC KLINGELHOFER, PHD

FOR FIRST COLONY FOUNDATION

MARCH 2022, rev. APRIL 2024

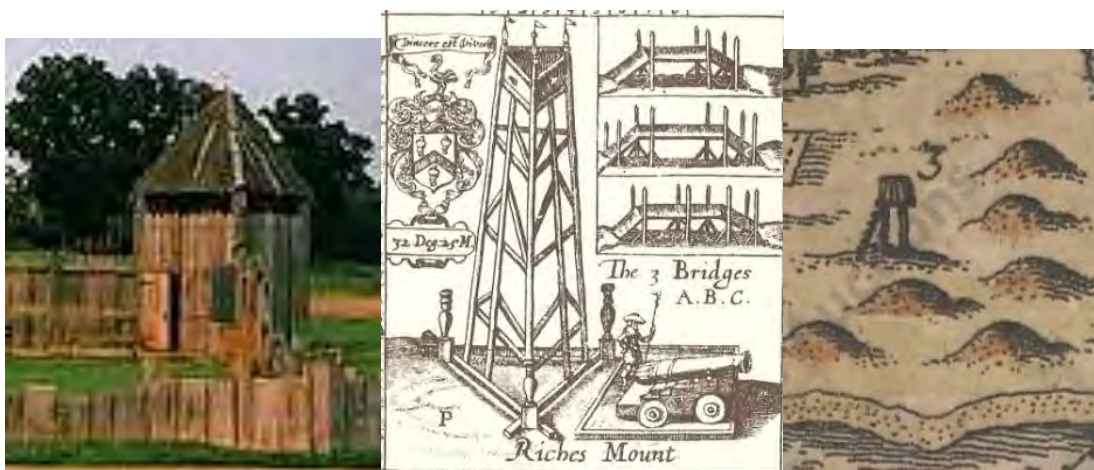
Wolstenholme Fort

Watchtower, Bermuda

Watchtower, St. Augustine

PWE first noted that JCH’s ‘outwork’ structure was nearly identical to the watchtower of Wolstenholme Fort, as identified by ECK, and it is logical to assume that here, too, form followed function. A military post would quickly establish a line-of-site view of a directional threats, in this case, the channel from the eastern approach to Roanoke Sound to the north end of Roanoke Island. An uninterrupted view from the highest point of land and at an elevation above thick vegetation required a watch tower. Illustrations exist of contemporary stand-alone wooden lookout towers erected by the Spanish at St Augustine, and later by the English at Bermuda. Undoubtedly, they were commonplace in low-lying localities like Roanoke Island.

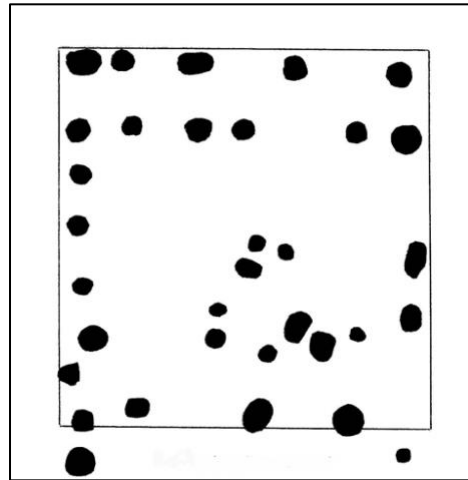
Structure 1, Governor's Land, Virginia, after Alain Outlaw, *Governor's Land: Archaeology of Early Seventeenth Century Virginia Settlements*, 1989.

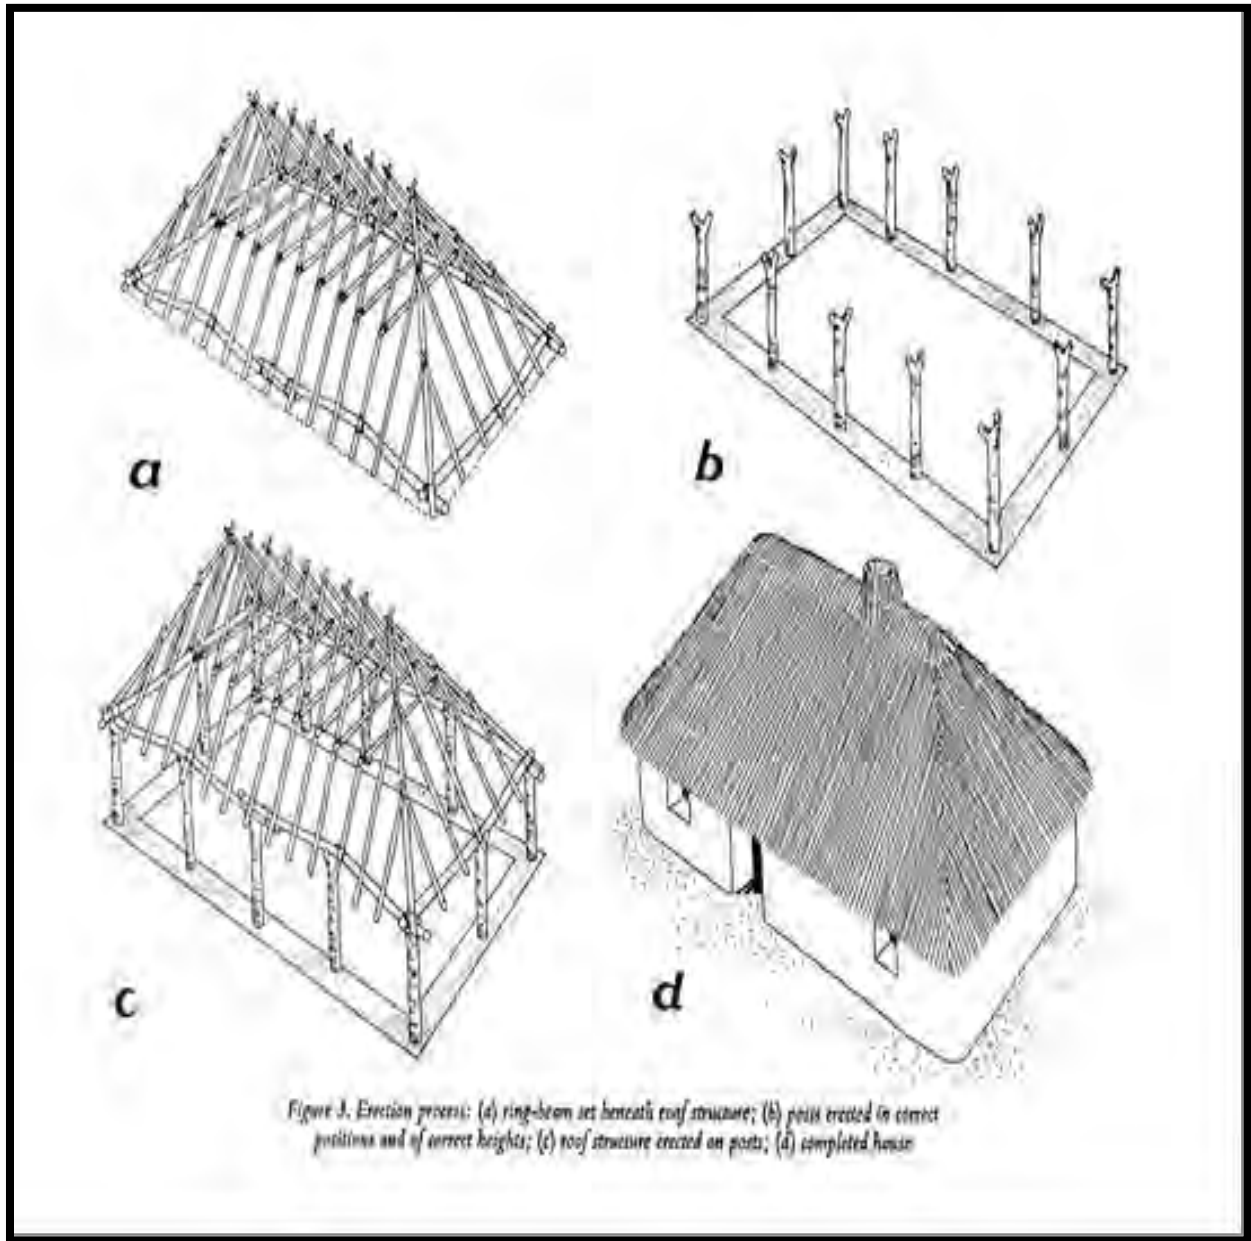
Cratchets in mud-and-stud building with hipped roof, by FWB Charles, "Post Construction and the Rafter Roof," *The Vernacular Architecture Group*, 13 (1981).

The workshop indeed functioned as a laboratory, though the term would not appear in English until the next century. Its north wall was the south palisade line, its west side somewhat east of the drainage ditch, its south side on the posts along the line cutting the red clay. The posts may have been forked timber *cratchets*. John Smith described the first structure at Jamestown as “A homely thing like a barn, set upon cratchets, covered with rafts, sedge and earth, so also was the walls...” Based on standing buildings of mud-and-stud construction in England, Eric Deetz believes that the workshop had a hipped roof and there are indeed two substantial postholes on the midpoint axis. The ridgepole ran 16’ with an additional 6’ slope to the structure’s west end. If the building was symmetrical, its east end would also lie 6’ beyond the east post, which places it right on the line of the eastern palisade. It was likely 28’ by 20-22’ (the east wall larger than the west) and fully roofed but open on three sides. The palisade-based northeast side would have protected the work area from the strong northeastern winds. The other sides may have used the local Algonquian house technology of woven mats that were rolled up when not in use. It is probable that the roof was probably made of thatch, as Lane refers to “reeds, that the [house] was covered with.” Examples of thatched-roof smithies survive in Britain – and even at a 19th-century president’s house in South Africa.

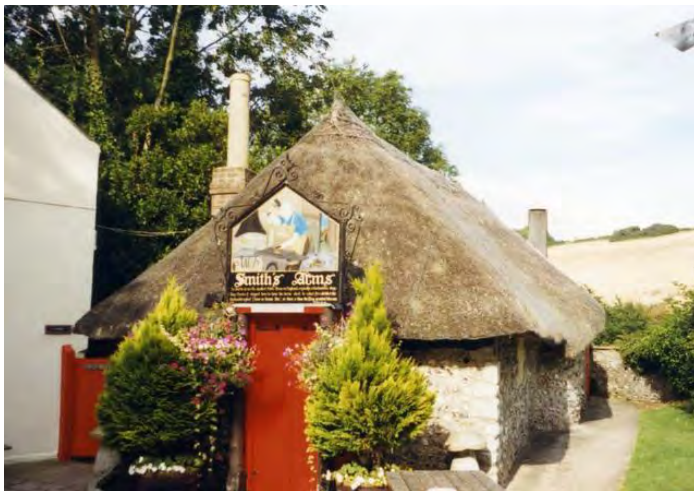
Thatched roof of former smithy in Dorset

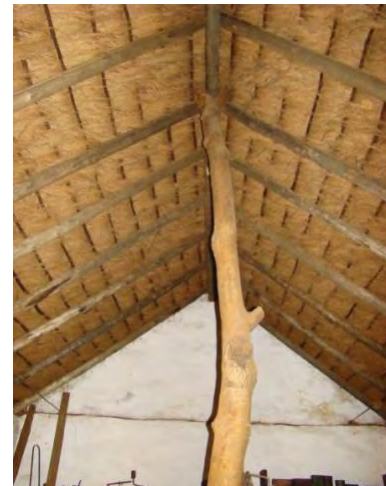
Pretorius Museum smithy roof
